EUCLID CHEMICAL

PROJECT PROFILE

PARKING GARAGE RESTORATION - TORONTO, ON

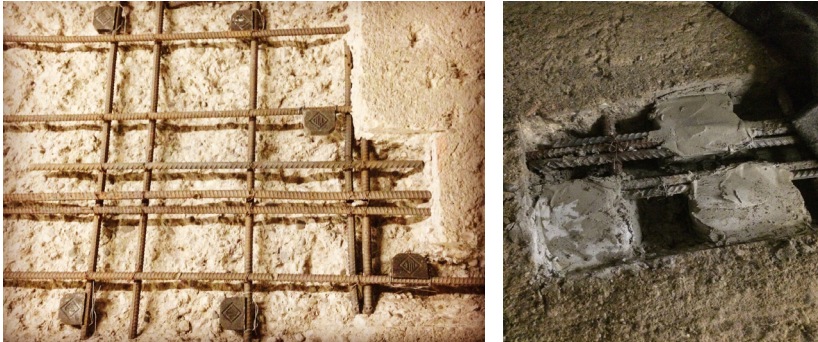
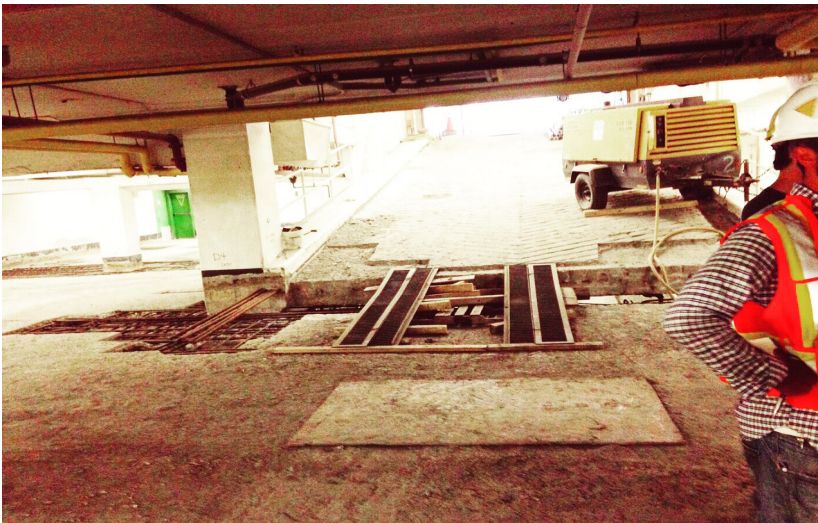
Portions of the waffle slab were cut out completely to replace the reinforcing steel in order to restore the structural integrity of the slab system. After shot blasting the remaining slab sections and forming from the underside, Sentinel GL Anodes were installed on the reinforcing steel at 12" on center on average; this was determined by the level of corrosion of the existing steel, the density of steel in the slab and the chloride level in the concrete. The anodes were then packed in the EucoRepair V100 mortar and the remaining slab area was treated with Duralprep A.C. for a proper bond of the 2" concrete topping.

Portions of the parking structure that could not be repaired in this manner due to lack of accessibility, were reinforced with steel plates on the un-der-side of the slab. The void area between the underside of the slab and the steel plate was then grouted in using NS Grout to complete the restoration.
