## PROJECT PROFILE

# BOX CULVERT VERTICAL & OVERHEAD REPAIR

Repair of spalled and delaminated concrete on a box culvert roof

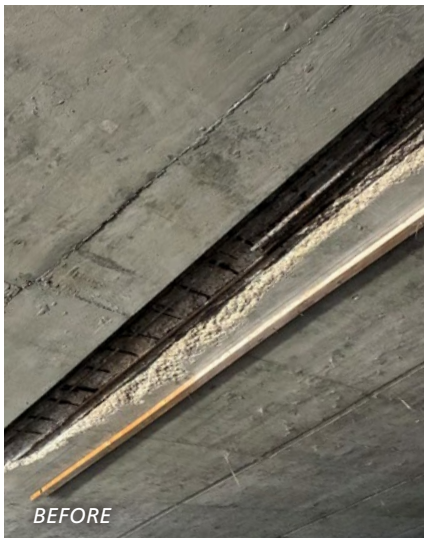
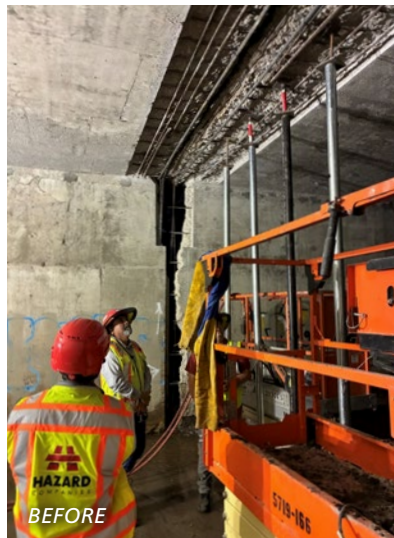
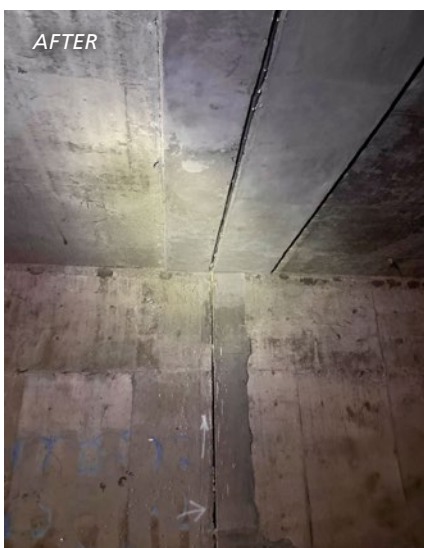
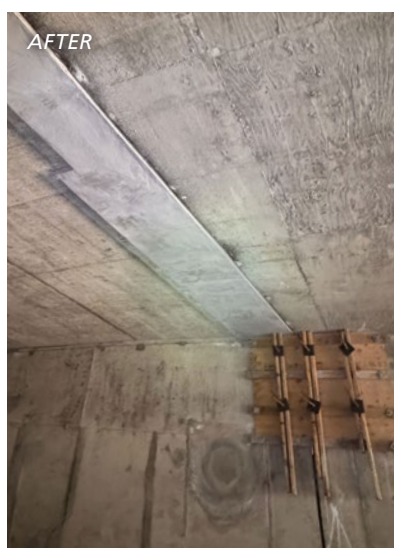
The repair of a box culvert in the Forest Creek recreation area involved the rehabilitation of the deteriorated roof structure experiencing concrete spalling, delamination, and exposed reinforcing steel. The repair scope required restoring structural integrity while ensuring durable performance under environmental exposure and service conditions.

A system approach using Euclid Chemical products was incorporated into the project specifications after being proposed to and approved by the structural engineer. Duralprep A.C. was utilized as both a bonding agent and anti-corrosion coating, providing strong adhesion between new repair materials and the existing substrate while protecting reinforcing steel from further corrosion. Its extended open time supported efficient placement under challenging field conditions.

EucoRepair V100 was selected for vertical and overhead repairs due to its low shrinkage, fiber reinforcement, and high bond strength, which are critical for minimizing cracking and ensuring long-term durability in structural repairs. Its rapid-setting characteristics also supported project scheduling requirements and reduced downtime. Eucolastic 1NS was used to seal joints.
